PRODUCT ADVISORY

TURBOSONIC PERFORMANCE LEAK PROOF TRIM CAP

In some model hydraulic pumps, hydraulic fluid can still leak even with the Turbosonic Performance Cap Installed. This advisory provides several tips to remedy this situation.

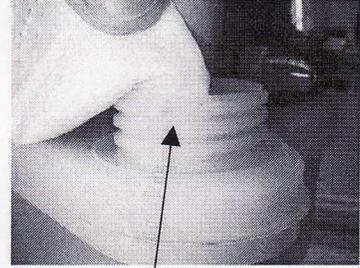
SOME MODEL RESERVOIRS HAD A VENT HOLE DRILLED IN THE THREAD, CHECK TO SEE IF YOURS IS THIS STYLE, IF SO THIS MUST BE SEALED WITH SILICONE SEALANT.

HOLE IN THREAD

CLEAN FILLER THROAT WITH A CLEAN CLOTH AND LACQUER THINNER OR ACETONE TO REMOVE OIL FROM THE SURFACE AROUND THE DRILLED HOLE.

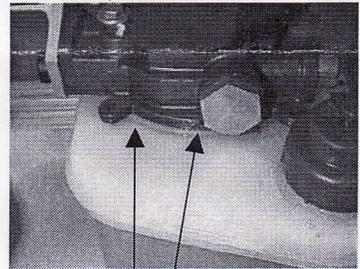
6. ON OCCASION THE BODY TO RESERVOIR O-RING WEEPS FLUID, TO REMEDY THIS

FLUID WEeping

7. REMOVE TANK BOTTOM 5/16 BOLT AND DRAIN FLUID, THEN REMOVE PLASTIC RESERVOIR
